Inquiry Report No. UB 2.1/13-213-2-2

Testing the ball throwing resistance of the "Acoustichoc 40" panel ceiling made of coated rock wool plates in conformity with

DIN EN 13964: edition of February of 2007

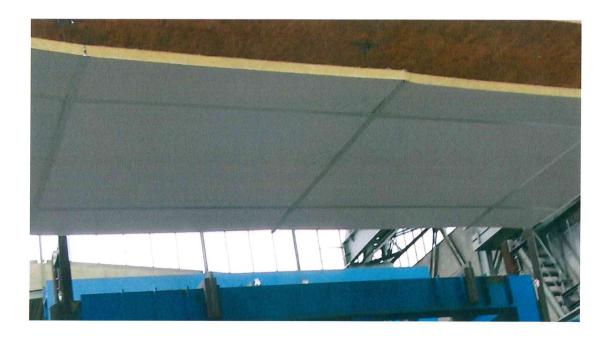
Figure A2-2: The view of the ceiling system after testing

The panel ceiling system tested did not show any visibly identifiable damage when tested as a ceiling element. This is the reason why the element is classified as "ball impact resistant" as per class 2A in conformity with DIN EN 13964:2007 based upon our test results.
